PN 83037-1: Mandatory Condensate Tee Upgrade

Trinity boiler Model Ti400 manufactured before Jan.8/07.
(For Ti100's through Ti200's use upgrade kit PN 83042-1.)

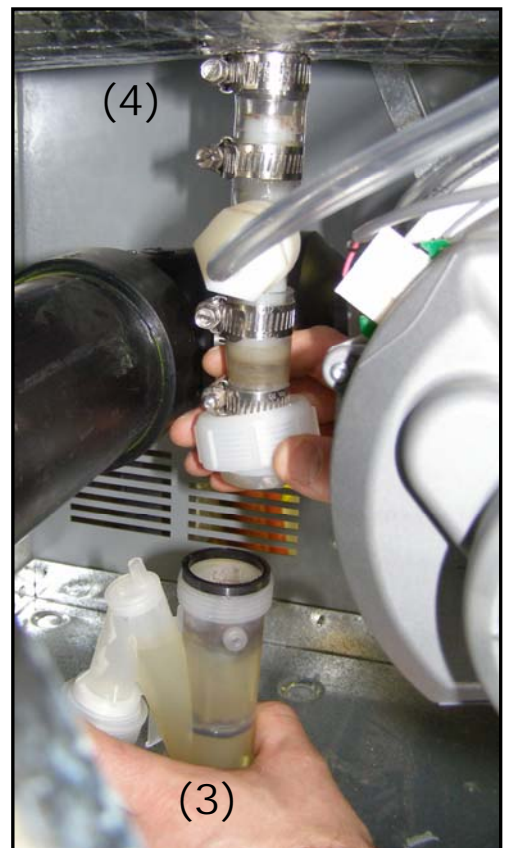
- 1) Identify the color of the Condensate Tee; if it is whitish replace it.
- 2) Turn power off to boiler.
- 3) Remove the condensate trap from underneath the condensate Tee.
- 4) Loosen the clamp securing the condensate drain to the Heat Exchanger.
- 5) Remove tubes from the old condensate Tee and re-install them on the new condensate Tee.

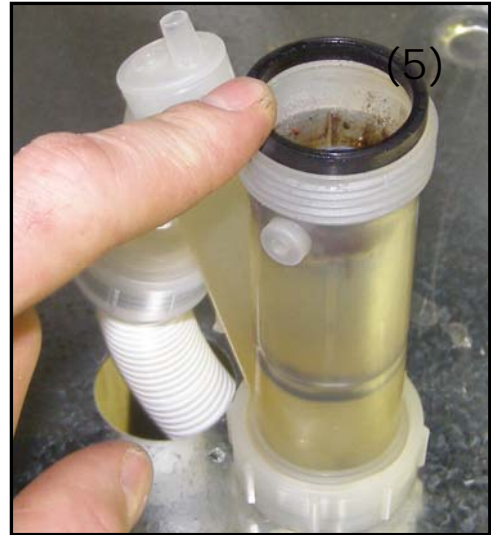
- 6) Installation is in the reverse order; ensure the gasket is properly installed before connecting the condensate trap.

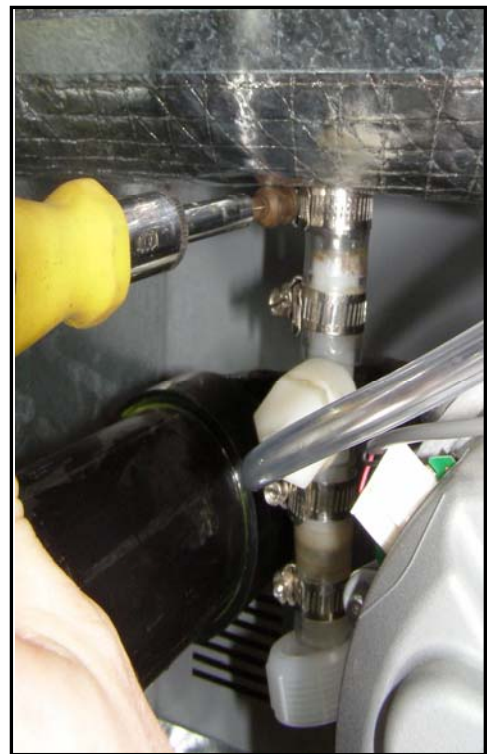
- 7) Check for air leaks with soapy water by:
- Turn gas supply off.
 - Unplug “Low-Voltage” Harness from combustion blower (Harness with Red, Black and Bare wires).
 - Turn power on.
 - Combustion fan is running at full speed, check for air leaks in the condensate drain.
- 8) Turn power off, re-connect the “Low-Voltage” harness to the combustion blower, turn power and gas on, and check for proper operation.
- 9) Fill out the “Reimbursement Form send to NTI for reimbursement.
